The Owner's Guide to Piano Repair

Focus On: Replacement of Worn Asian-Design Hammer Butts and Flanges

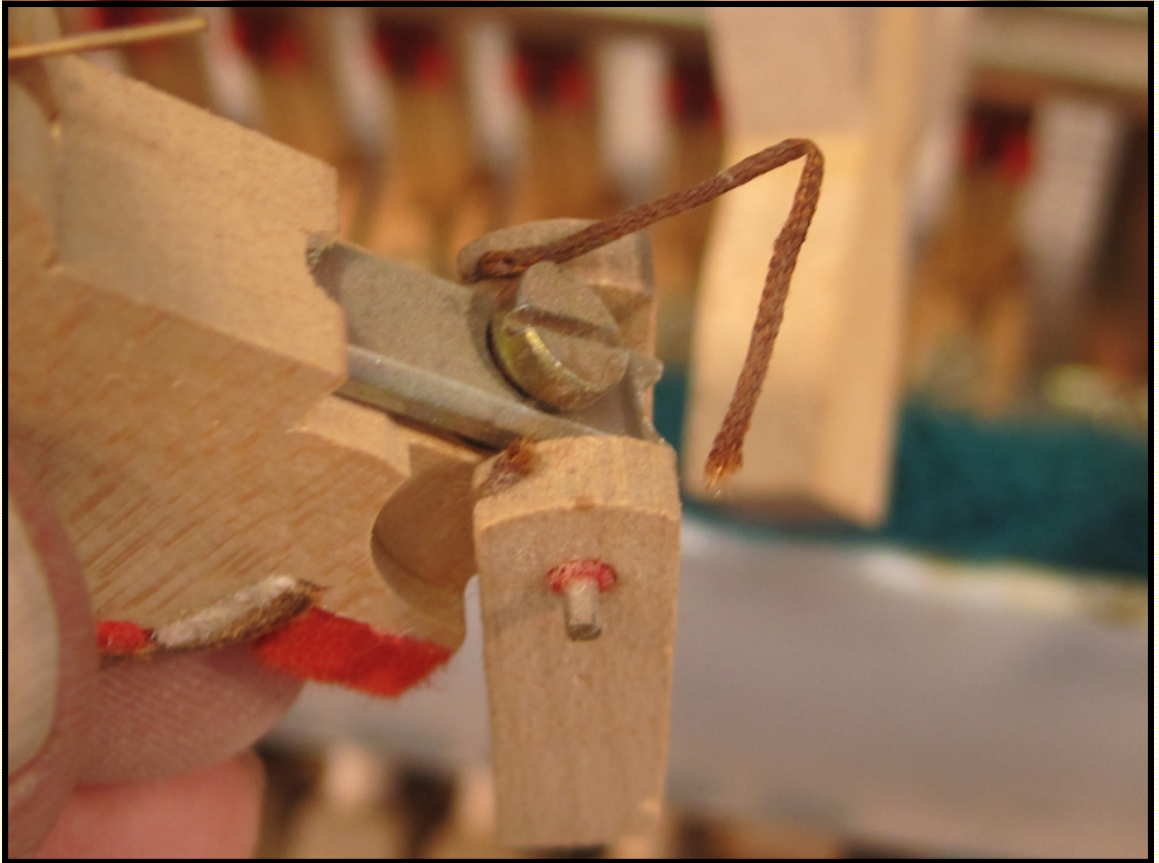
The Achilles heel of Yamaha, Kawai and other Asian-made pianos is a hammer butt assembly that relies upon a small braided cord to hold an essential spring in check. After years of use this cord is prone to breaking (as shown in photo on cover), which causes the piano action to perform unsatisfactorily.

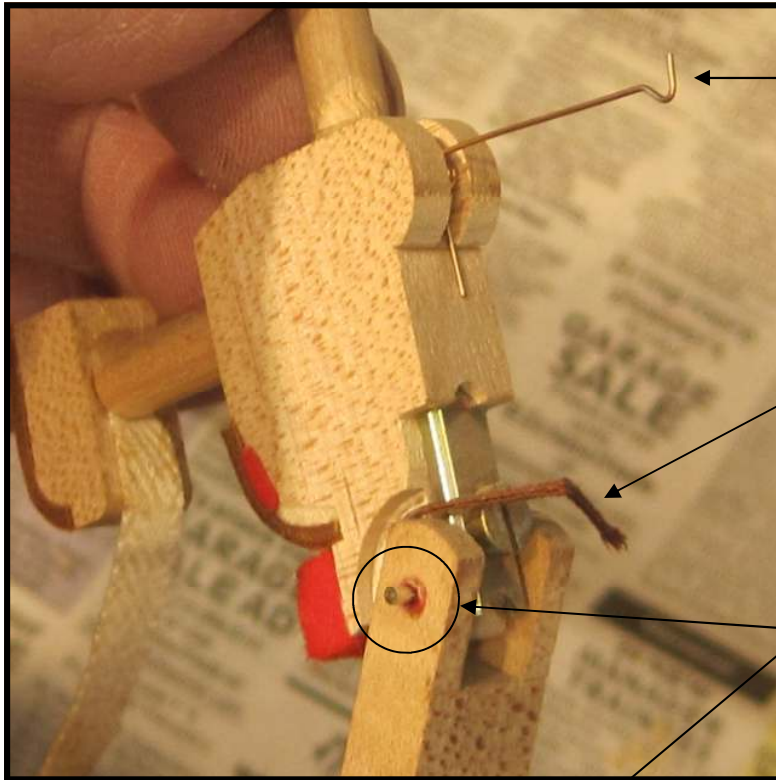
The following photos of used hammer butt / flange assemblies from a 1980s Yamaha studio upright illustrate the most common problem areas.

Hammer butt return spring: When held in check by the flange cord, this spring swiftly returns the hammer butt to its rest position so that it's ready to fire again the next time the note is played.

Flange cord: Although strong enough to hold the continuous tension of the return spring for decades, it eventually can give out and break.

Action center: The pivot point for the hammer butt. As the felt bushing and brass pin become worn, the fit of the pin loosens, causing sloppy play. The pins in the photos have worked loose entirely from one side of the flange, causing extreme wobble.

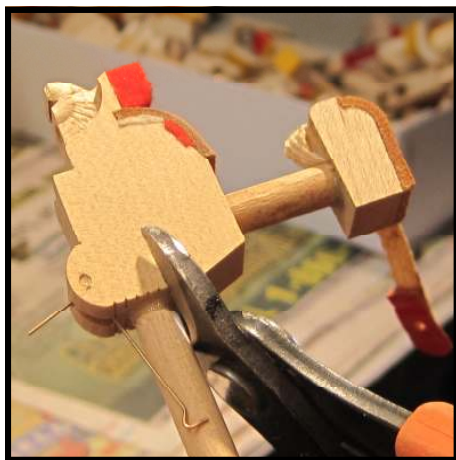
The old hammer butts are then removed from the hammer shanks, usually by using a pair cutters to cut along the grainline. Several cuts are required to remove the old part, at which time the shank needs to be cleaned of any remaining wood and glue.

Once this is done, the new hammer butt / flange assemblies are installed in the action.

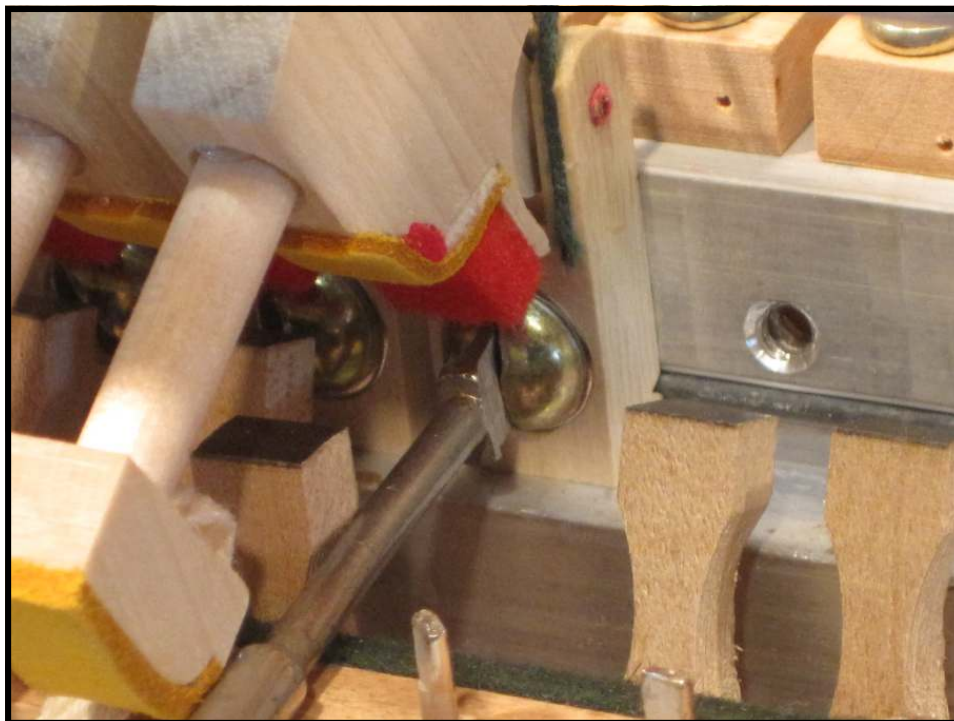
New hammer butt / flange assemblies being installed.
